Bulletin No.: PIT5839

### PIT5839 Radio System Settings Lost or Returning to Default Values

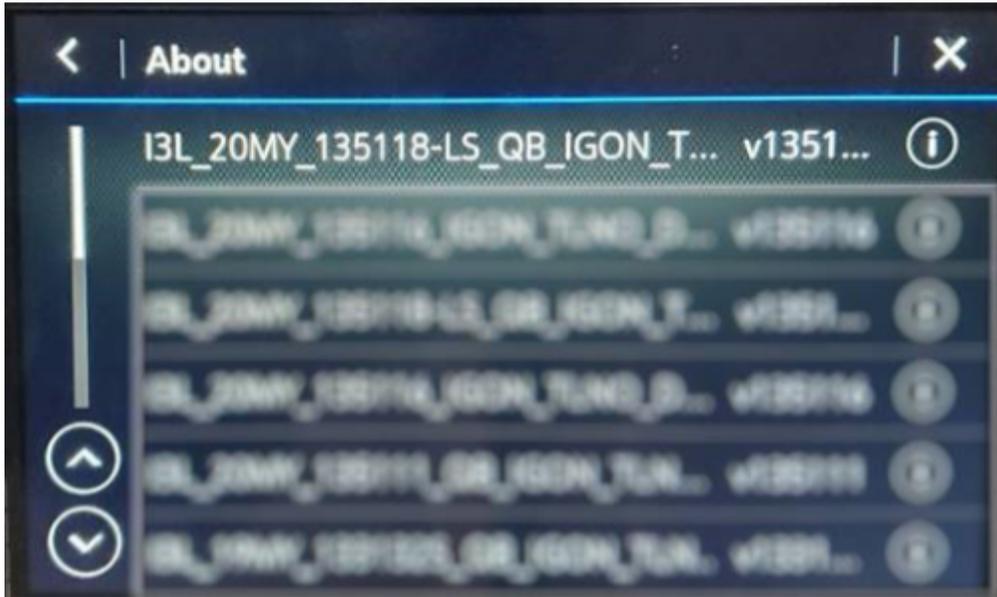
1. Verify the radio software version as this issue only pertains to version V135118. On the radio display, select Home, Settings, About. On this page will be what appears like a long file name. In the middle of this file name will be 135118.

- If the version is V135118 do not attempt repairs.
- If the version is numerically less than V135118 then this PI does not apply. Refer to SI for diagnostics.
